# ***SERVICE INFORMATION BULLETIN***

**DATE:** July 2013 (Rev. A)

**SUBJECT:** Pulse Pump Hose Line Routing Inspection

**MODELS AFFECTED:** EcoGen Model 5818-1 Serial Numbers 7995894 to 8176897

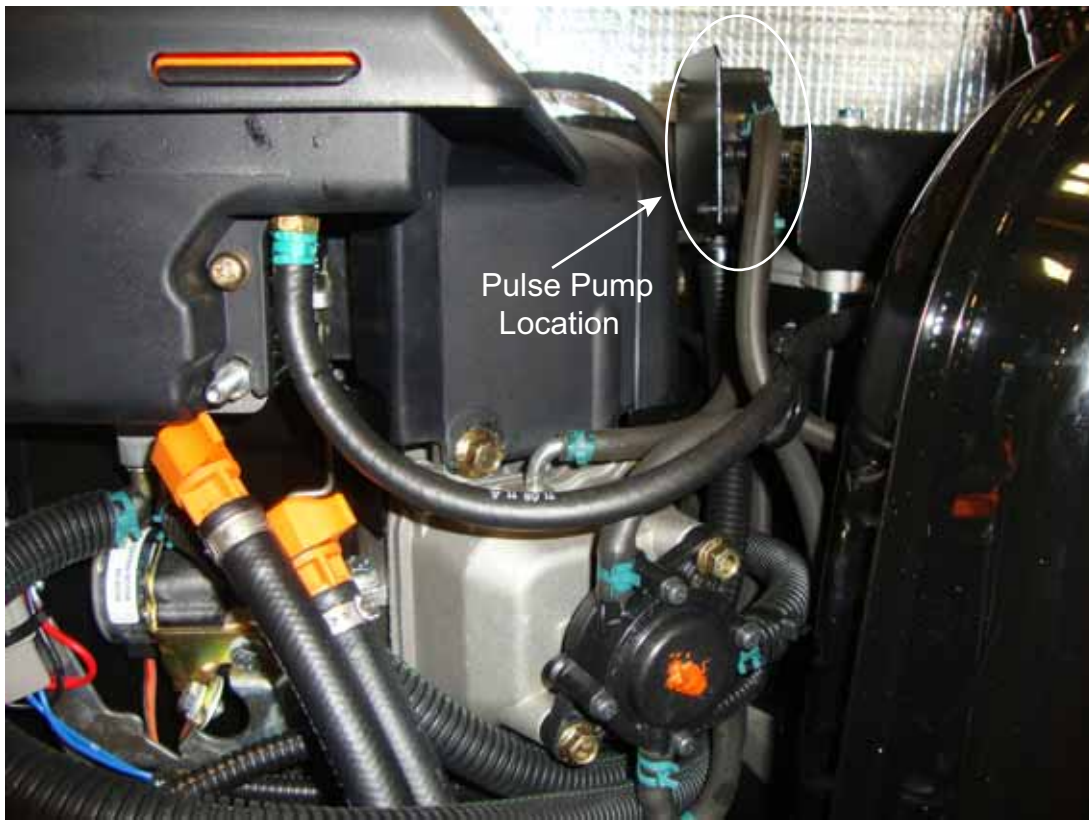
***Figure 1. Pulse Pump Location***

1. Before beginning the procedure, refer to the owner's manual for all warnings and cautions. Remove the 7.5 Amp fuse and disconnect the battery.
2. Locate the pulse pump. See Figure 1.

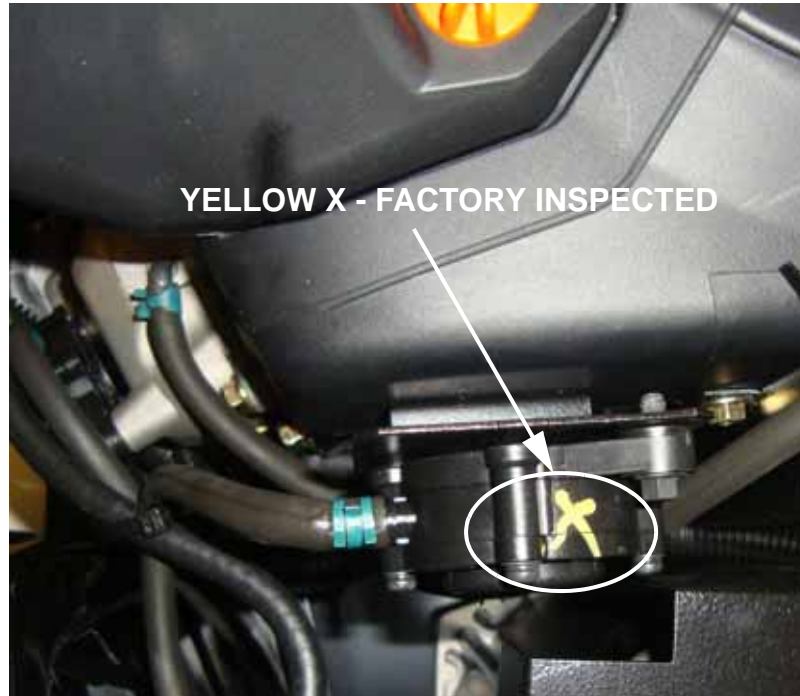
3. If the top of the pulse pump has a yellow X, it has been factory inspected and all hoses have been routed correctly. No action required. See Figure 2.

**Figure 2. Yellow X - Pump is OK**

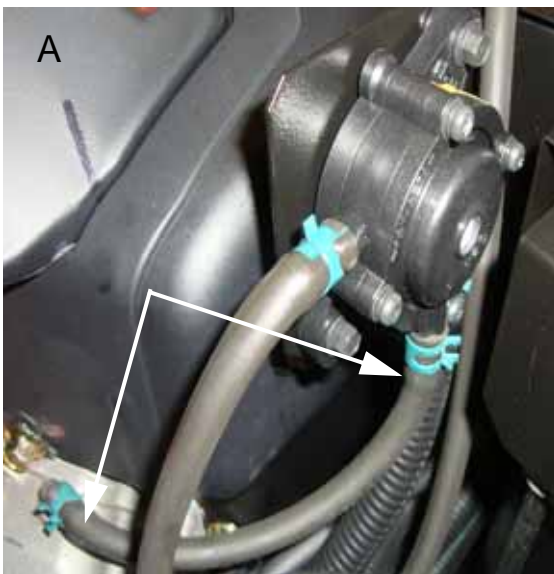
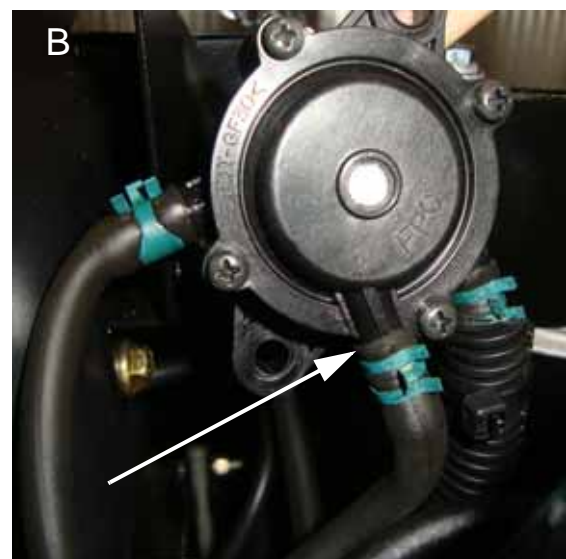
4. If there is no yellow X, inspect to see if the hose routing is correct or not. Figures 3 A&B show the CORRECT routing of pulse hose at the pulse pump.

**Figure 3. A&B Pulse Hose Routed CORRECTLY to P port**

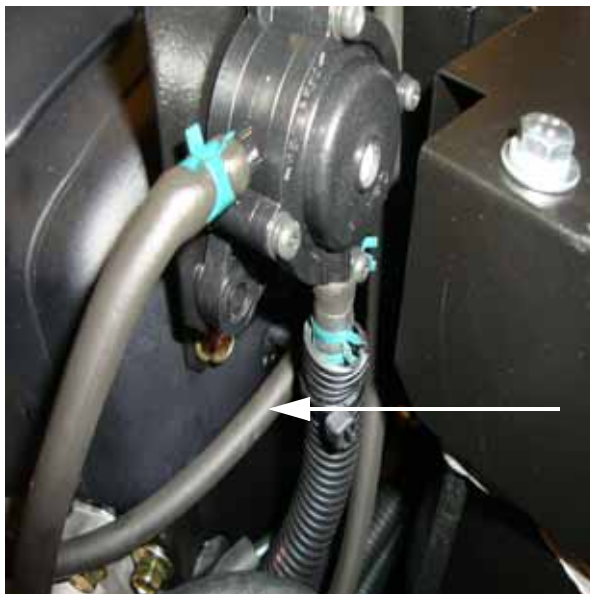
**PROBLEM:** It is possible that the hoses are connected incorrectly. This can cause the crankcase to fill with excessive amounts of oil.

**Figure 4. Pulse Hose Routed INCORRECTLY**

5. See Figure 4. Pulse Hose is routed INCORRECTLY.  
Change the locations of the hoses at the pulse pump fittings as shown in Figure 3.
6. Reconnect battery cables, positive (+) red first. Install the 7.5 Amp fuse.
